## INSTABILITY OF MULTISTAGE COMPRESSOR K1501

Zhou Ren-mu  
 Hangzhou Steam Turbine Works  
 Hangzhou Zhejiang, People's Republic of China

This paper primarily discusses the failure and the remedy described above.

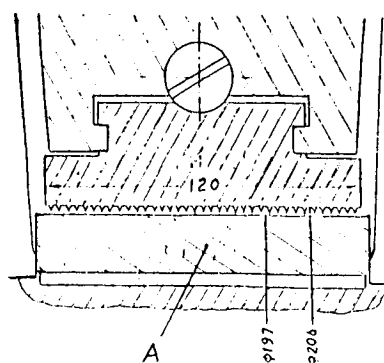
Figure 3. - Labyrinth construction.

Intensive vibration originated from the low-pressure compressor, K1501LP. Figure 2 shows the longitudinal section of its rotor. Table I shows the parameters of the tilting pad of both bearings. Figure 3 shows the gas labyrinth construction of the middle diaphragm. Figure 4 provides a critical speed map and mode shapes for the rotor.

(2) The gas labyrinth of the middle diaphragm and the ends of the cylinder were worn out. Some wear scars remained on the surface of the shaft.

- (1) Six teeth in the middle of the diaphragm labyrinth were removed.
- (2) The ratio of bearing width to diameter was decreased from 0.40 to 0.39 mm.
- (3) Additional displacement transducers were installed on bearings 074 and 075 (fig. 1) to improve vibration monitoring.

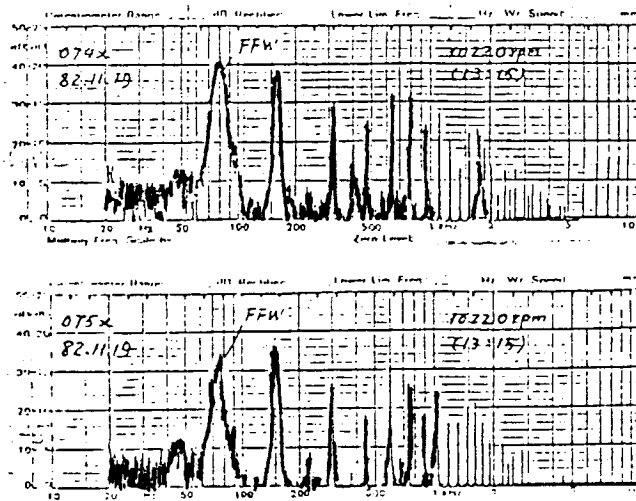
Figure 5 shows frequency spectra of the shaft vibration in direction  $x$  on bearings 074 and 075 at a speed of 10 220 rpm as measured by a transducer on November 19, 1982. From figure 5, the rotating speed was 170.3 Hz, and the frequency of fractional frequency whirl (FFW) was 80 Hz. The frequency ratio  $\eta_f$  equalled 0.47. The vibration amplitudes of the components in this figure are almost equal. Figure 6 shows a frequency spectra of the shaft vibration in direction  $y$  on bearing 074 and in direction  $x$  on bearing 075 at 9460 rpm on November 19, 1982. Again, the vibration amplitudes were almost equal. The frequency of FFW was 77 Hz (measured), the rotating frequency was 157.7 Hz, and the frequency ratio  $\eta_f$  equalled 0.488. So obviously the FFW appeared at 9460 rpm.

Figure 5. - Frequency spectrum of shaft vibration in bearings 074x and 075x at 10 220 rpm (Nov. 19, 1982).

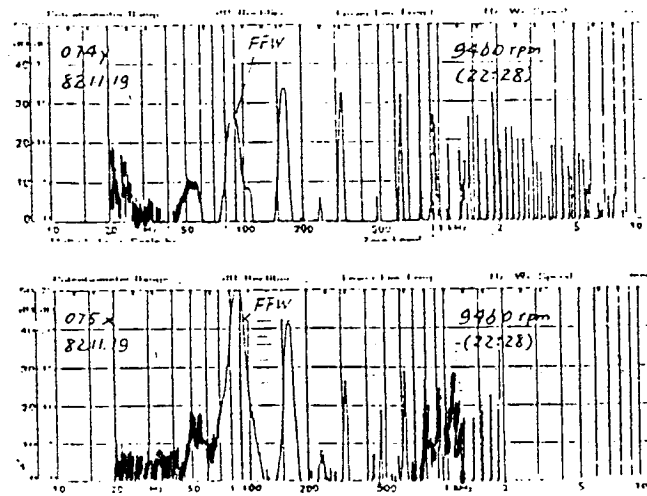
Figure 6. - Frequency spectrum of shaft vibration in bearings 074y and 075y at 9460 rpm (Nov. 19, 1982).

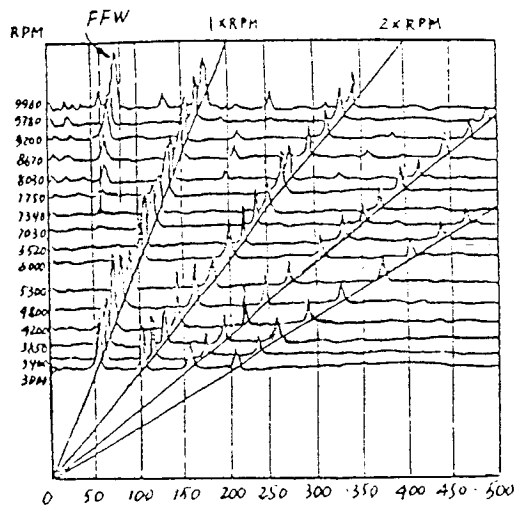
Figure 7. - Vibration speed-spectrum map.

Figure 7, which gives a speed-spectrum map from an experimental recording, indicates that the FFW appeared just at 8000 rpm and that  $\eta_f$  equalled 0.5. Amplitude increased rapidly with increasing speed, but frequency dropped slightly.

The tests just described make clear the inevitability of rotor instability. But comparisons between figures 7 and 14 show that the latter tests did not produce considerable FFW before instability appeared, and the amount was less than that of the operational speed-frequency map by 25 dB (fig. 12). Just before the rotor became unstable (fig. 14), the frequency of the FFW was 74 Hz/sec (which is the same as in fig. 12). This frequency suddenly rose to 80 Hz after 5 sec (which is in agreement with fig. 13). The frequency ratio  $n_f$  equalled 0.4465.

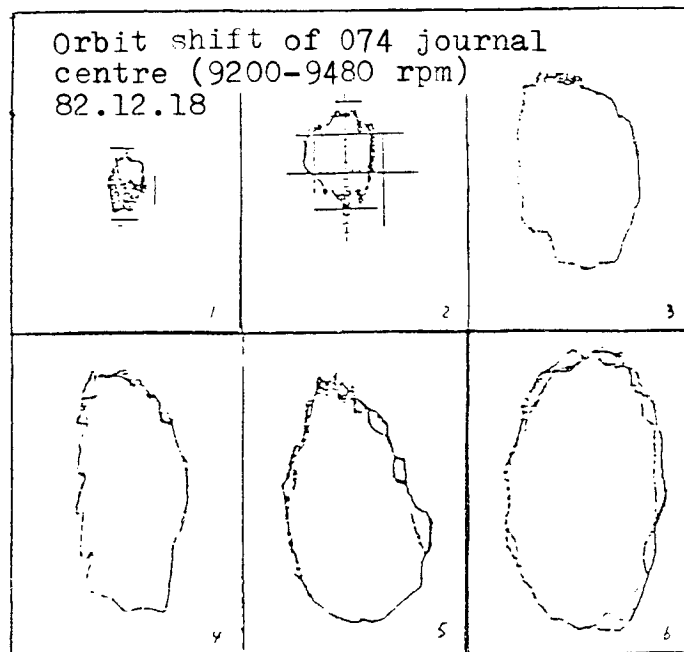
Figure 8. - Orbit of shaft center on bearing 074 from 9200 to 9600 rpm.

Figure 8 shows an evolution of the shaft center orbit measured on bearing 074 at 9200 to 9480 rpm on December 18, 1982. It was photographed from the cathode oscilloscope.

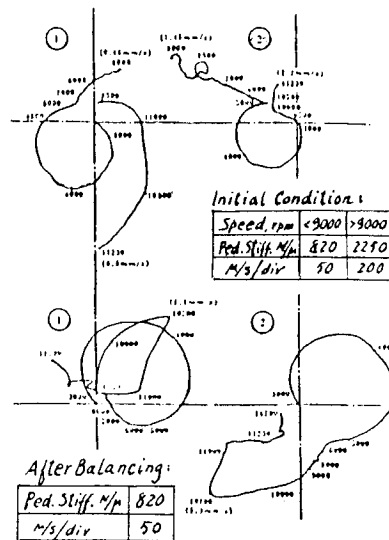
Figure 9. - Nyquist tracks before and after rotor balancing correction.

Figure 9 shows the Nyquist tracks before and after the balancing correction. Before the correction the severity of the bearing vibration increased quickly when the speed exceeded 9000 rpm. For the sake of safety the pedestal stiffness was increased from 820 to 2250 N/ $\mu$ m. When the speed reached 11 230 rpm, the two bearings were vibrating at 6.5 and 2.2 mm/sec, respectively. This result indicated poor balancing. We found that the mixed vibration of the second and third modes appeared before the second critical speed was reached. Using the method of modal separation, we corrected the unbalance of the rotor. The bearings were vibrating at only 0.3 and 0.35 mm/sec, respectively, when the pedestal stiffness was restored to 820 N/ $\mu$ m. The first

critical speed was 4000 rpm and the second was 10 700 rpm; these speeds are in agreement with the results of our calculation. The results of our experiment on insensitivity indicate that the rotor is sensitive to unbalance at 11 230 rpm. (This does not conform to American Petroleum Institute (API) standards.)

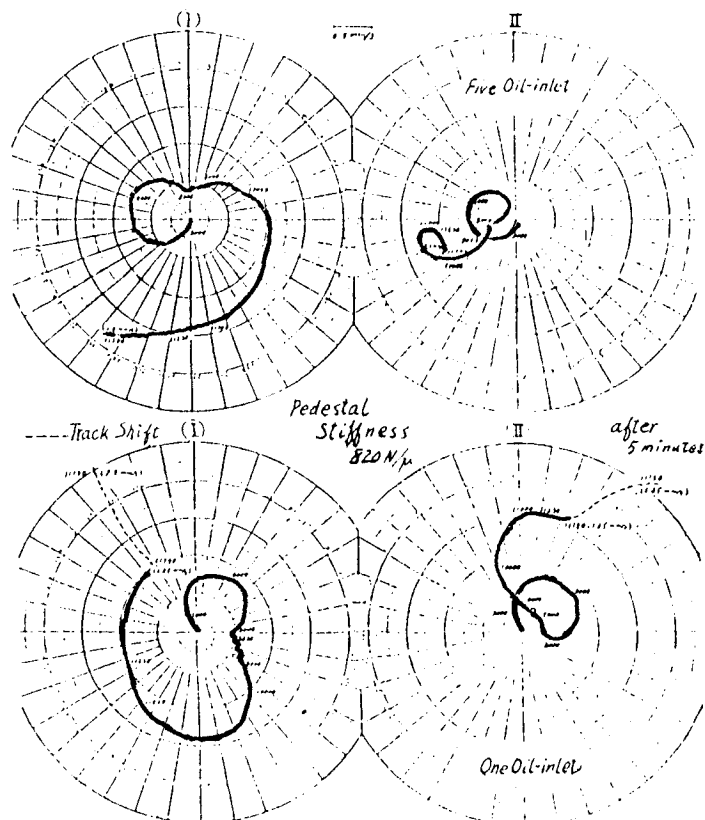
Figure 10. - Influence of number of oil-inlet holes on shaft vibration.

The Nyquist tracks of the rotor with one and with five oil-inlet holes (one hole for each pad) in the bearing are shown in figure 10. The dotted lines in the figure show a change of rotor vibration for one oil-inlet hole. However, oil whip did not take place. The oil clearance was increased from 0.15 to 0.20 mm, but the state of the shaft vibration did not change. It was impossible to test the labyrinth-seal excitation, for the rotor was driven in a vacuum chamber.

In brief, high-speed balancing showed clearly that the instability of the rotor did not come from the oil whip.

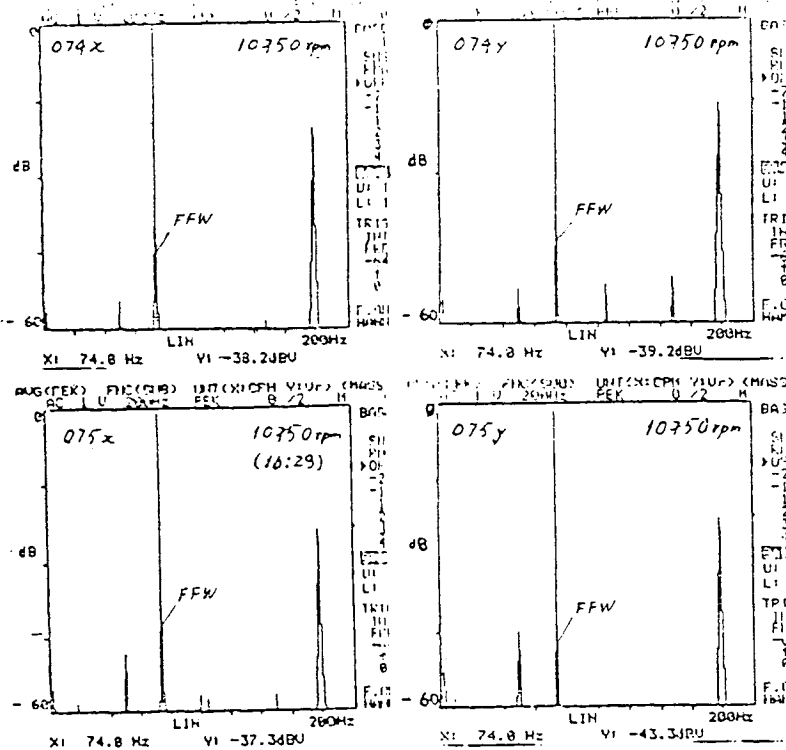
Figure 12 shows a real-time analysis of the shaft vibration during stable operation. Figure 13 shows the same analysis during a period of instability. Figure 14 gives a three-dimensional spectrum analysis of the shaft vibration in direction x on bearing 075. Figure 15 shows an orbit of the shaft center during instability.

Figure 12. - Real-time analysis of shaft vibration at 10750 rpm before rotor instability.

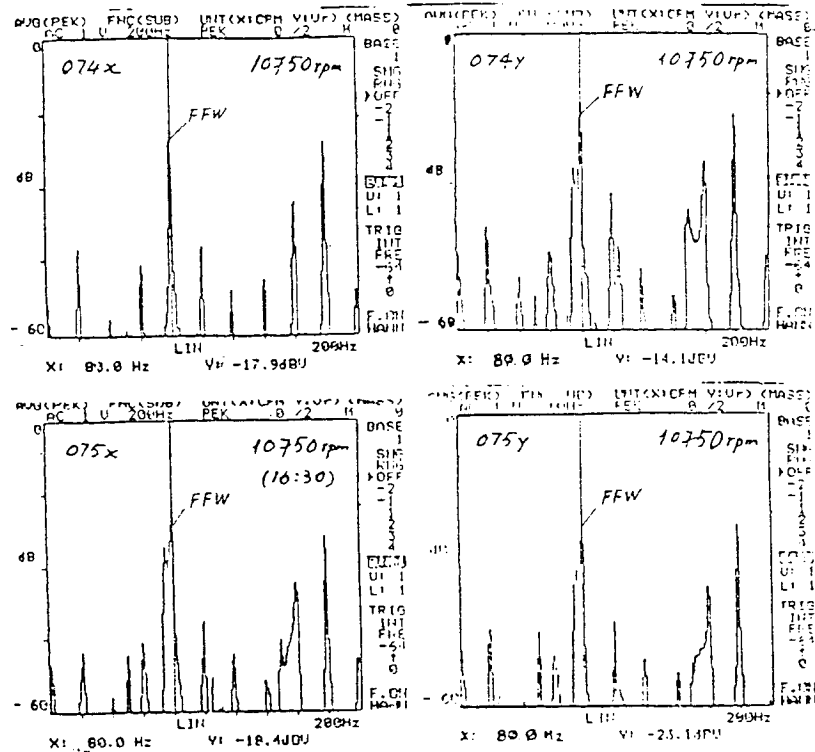
Figure 13. - Real-time analysis of shaft vibration at 10 750 rpm during rotor instability.

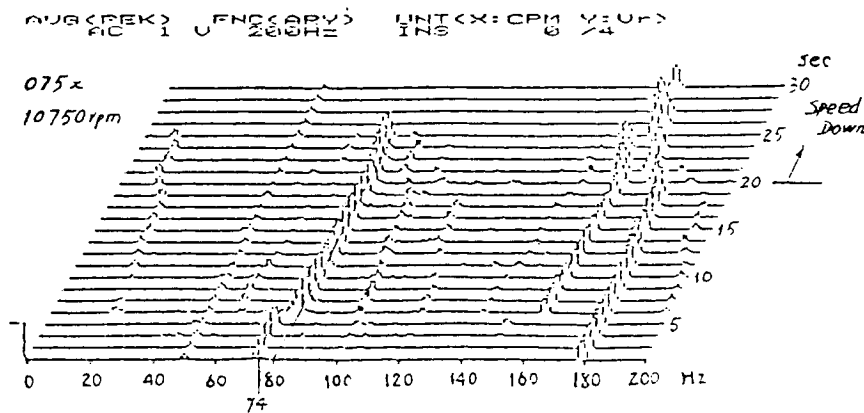
Figure 14. - Three-dimensional spectrum of shaft vibration in bearing 075 at 10 750 rpm during instability.

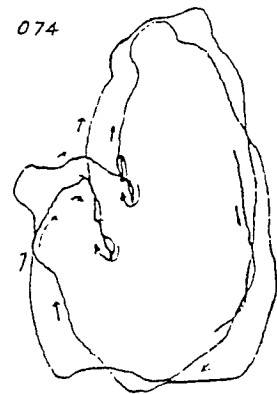
Figure 15. - Orbit of shaft center on bearing 074 at 10 750 rpm during instability.

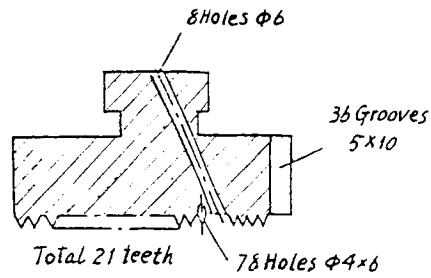
Figure 16. - Construction of  
new labyrinth.

Although much important data on the dynamic properties of the rotor were acquired through the three steps of the tests, the nature of this instability has not been directly determined. According to the information and inference, however, the origin of the instability is labyrinth-seal excitation. The compressor manufacturer also provided some suggestions for improvements.

Finally, a decision was made that gas should be injected into the labyrinths of the middle diaphragm. The new construction is shown in figure 16. After this measure was taken, the instability was eliminated. Figure 17 shows a frequency spectrum of the shaft vibration on bearing 074 at 10 690 rpm before corrective measures were taken, and figure 18 shows this spectrum after corrective measures were taken. It can be seen that the FFW was eliminated.

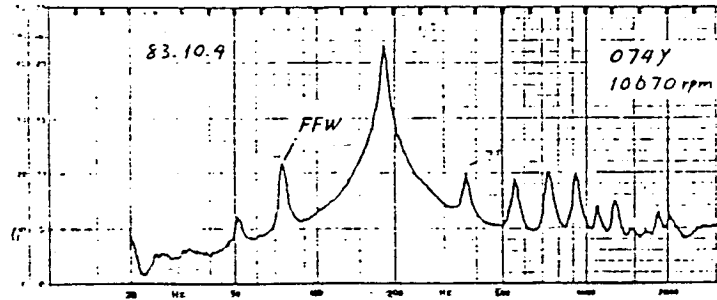
Figure 17. - Frequency spectrum of shaft vibra-  
tion on bearing 074y taken with old labyrinth.

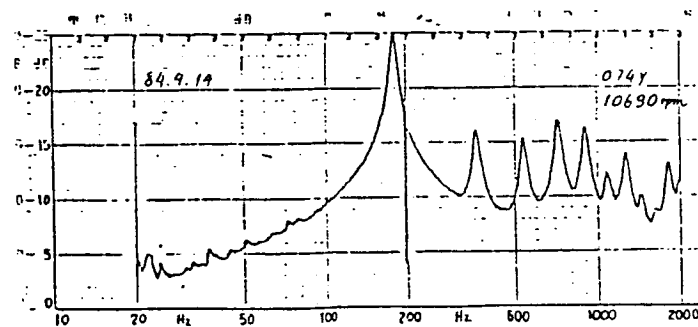
Figure 18. - Frequency spectrum of shaft vibra-  
tion on bearing 074y taken with new labyrinth.
